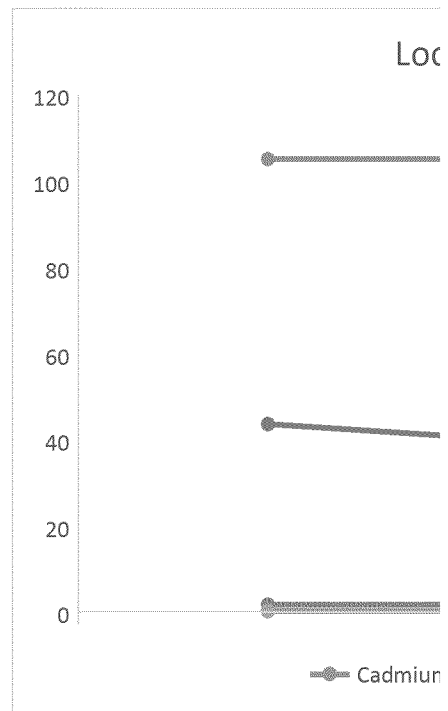
Location: 32nd Street Bridge

| ocation ID | Date Sampled | Cadmium | Copper | Lead | Manganese | Zinc |
| 32nd St Br | 8/5/2015 | 0.178 | 1.7 | 0.24 | 105 | 43.5 |
| 32nd St Br | 8/6/2015 | 0.16 | 1.56 | | 105 | 37.8 |
| 32nd St Br | 8/6/2015 | 0.19 | 1.62 | 0.115 | 97.8 | 49.1 |

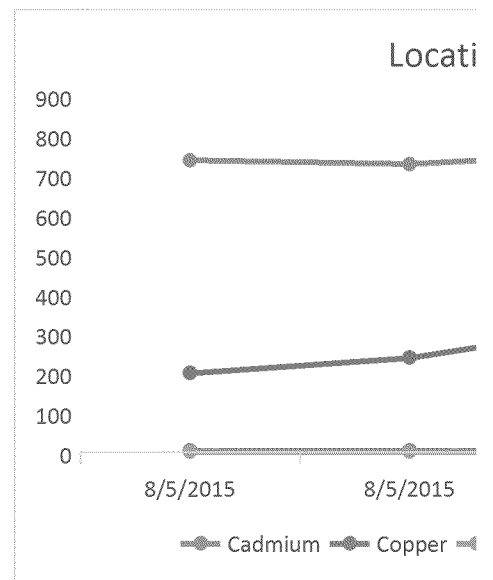
on: A68

| Location ID | Date Sampled | Cadmium | Copper | Lead | Manganese | Zinc |
| A68 | 8/5/2015 | 0.828 | 3.45 | 0.232 | 737 | 199 |
| A68 | 8/5/2015 | 0.815 | 3.16 | 0.283 | 727 | 238 |
| A68 | 8/5/2015 | 0.974 | 3.52 | 0.82 | 757 | 324 |
| A68 | 8/6/2015 | 0.85 | 3.26 | 0.329 | 817 | 326 |

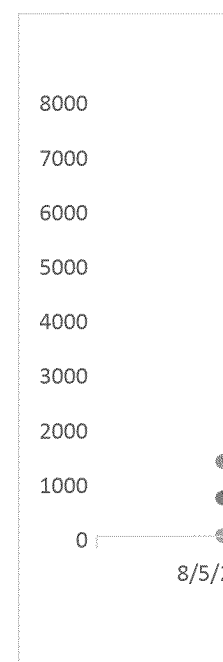
Location: A72

| Location ID | De Sampled | Cadmium | Copper | Lead | Manganese | Zinc |
| A72 | 8/5/2015 | 1.81 | 9.27 | 0.225 | 1370 | 699 |
| A72 | 8/5/2015 | 15.2 | 1410 | 50.7 | 6650 | 4020 |
| A72 | 8/5/2015 | 4.29 | 205 | 3.12 | 1810 | 1210 |
| A72 | 8/5/2015 | 2.59 | 11.4 | 0.118 | 1320 | 733 |
| A72 | 8/6/2015 | 2.11 | 7.63 | | 1160 | 609 |

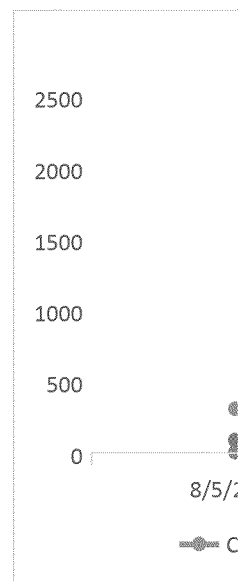
Location: Bakers Bridge

| Location ID | Date Sampled | Cadmium | Copper | Lead | Manganese | Zinc |
| Bakers Bridge | 8/5/2015 | 0.353 | 2.28 | | 306 | 85.8 |
| Bakers Bridge | 8/6/2015 | 0.336 | 1.88 | | 296 | 110 |
| Bakers Bridge | 8/6/2015 | 5.32 | 189 | 1.56 | 2090 | 1700 |

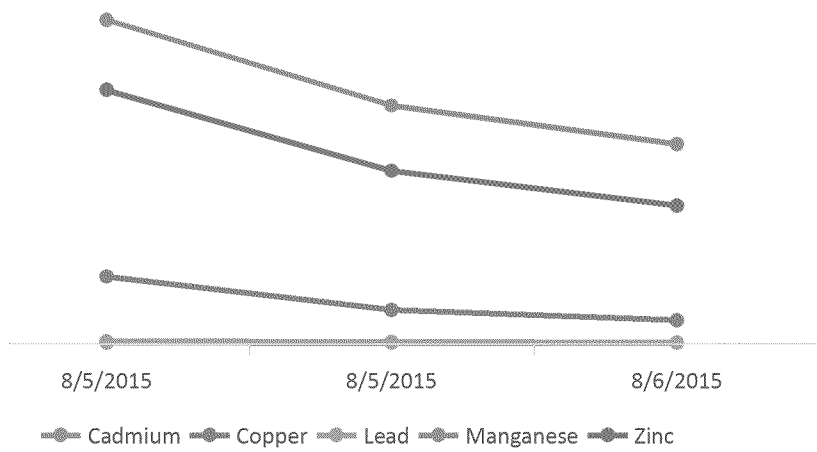
Location: CC48

| ocation ID | Sampled | Cadmium | Copper | Lead | Manganese | Zinc |
| CC48 | 8/5/2015 | 30.6 | 2260 | 73.9 | 10900 | 8540 |
| CC48 | 8/5/2015 | 19.1 | 1130 | 54.1 | 8020 | 5820 |
| CC48 | 8/6/2015 | 14.2 | 786 | 30 | 6720 | 4650 |
